REPRESENTATIONS OF LOCAL IDENTITY THROUGH LANDMARKS: THE REHABILITATION OF RUPEA FORTRESS, ROMANIA

Zoltan MAROȘI

Babeș-Bolyai University, Cluj-Napoca, Faculty of Geography, ROMANIA

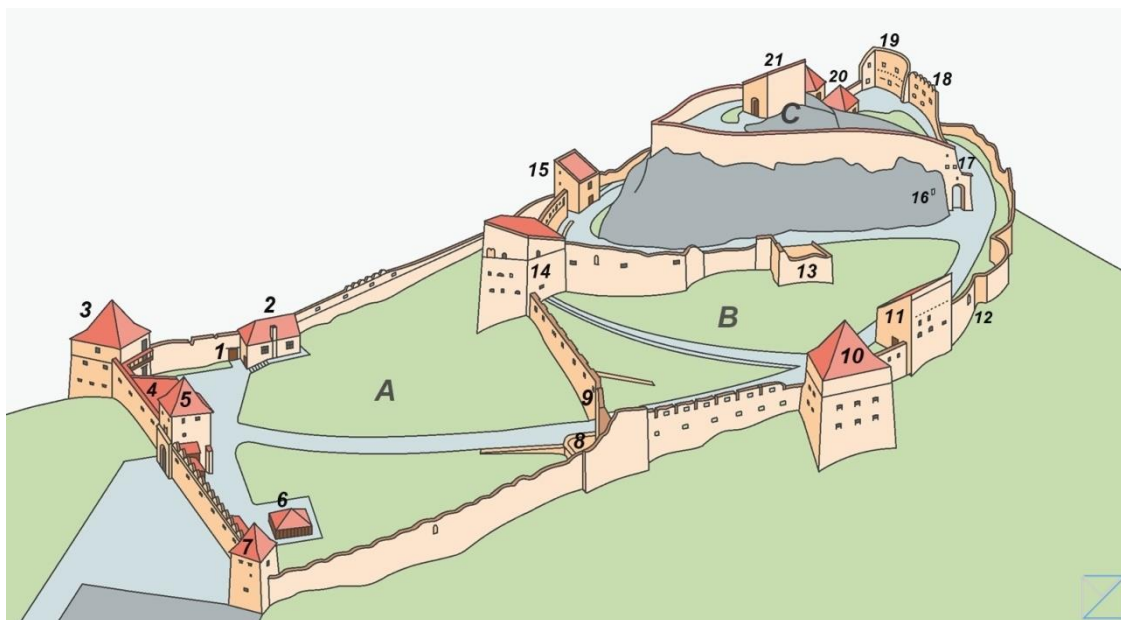
Figure 2: Bird's-eye view drawing of Rupea Fortress in its current form (west side)
 Drawing by MAROȘI Zoltan, 2016

1. Pedestrian entrance on the west side
 2. The Guardian's House
 3. The Lard & Bacon Tower
 4. Military warehouse
 5. The Main Gate Tower
 6. The water well
 7. The Servants' Tower
 8. The Galt's Tower
 9. The Middle Fortress Gate
 10. The Gresbig Tower or Scouts' Tower
 11. Chapel
 12. The Scouts' Secret Gate
 13. The Thickened Tower
 14. The Pentagonal Tower
 15. The Scribes' Tower
 16. Inscription in marble
 17. The Upper Gate and Tower
 18. Barracks
 19. The Regional Administrative Chambers
 20. Preserved private houses from the 17th century
 21. The Upper Chamber or The Watchmen's House
- A. The Lower Fortress
 B. The Middle Fortress and
 C. The Upper Fortress

The pedestrian entrance to the fortress (Figure 2.1) was built in the 17th century and, before the rehabilitation, it was used by tourists and locals, for direct access from the town centre. Today it is not used, but the massive wooden gate overlaid with metal strips is preserved in its original form, being one of the oldest wooden structures from the fortress. The gate also preserves the mechanism of the original lock and the fortress keys. Near this secondary gate, was built, in 1850 (probably on the site of another structure), *The Guardian's House* (Figure 2.2), which was used before the rehabilitation by the fortress key holders, and, afterwards, by security guards and staff members. *The Main Gate Tower* (Figure 3.5) is used today to enter *The Lower Fortress* (Figure 2.A), but before the rehabilitation, this gate was open only for carts and carriages, pulled by horses or oxen, and for important events. Considering the fact that the fortress had private

Between the The Lard Tower and the Main Gate Tower, was built, in the 19th century, a *Military warehouse* (Figure 2.4), but it was also used as a stable for horses. This recent building has replaced the original wall-walk between the two towers, but kept the firearms openings, which made the building defensive. On the other side of The Main Gate Tower, the covered wooden wall-walk was a direct access to *The Servants' Tower* (Figure 2.7), the original wooden structure had not been preserved, but, through rehabilitation, it was partially reconstructed. The semicircular merlons of this wall (Figure 3, between 5 and 7) are not the original ones, many unprofessional changes were made in 1973 during the shooting of the movie "Nemuritorii" [The Immortals] by Sergiu Nicolaescu, inside the fortress.

The Servants' Tower (Figure 2.7) is located in the northwestern corner of the fortress, slightly smaller than the other two towers from this alignment, but not less defensive. The town's official emblem was inspired by these three towers, represented on a blue shield with rounded edges (Decision of the Romanian Government no. 115/2013). The tower was probably used by stablemen and servants, in accordance with the fact that the extended area (approx. 4,100 m²) of *The Lower Fortress* was designed as a place to safely keep the cattles, horses, and other animals in case of a siege. The wealth of a family was reflected in the number of the owned animals and protecting them was not only for strategic reasons, but also for survival after a devastating invasion. It is possible that along the west wall of The Lower Fortress, there were several wooden stables, but their traces were lost in the last five centuries. The presence of the 42 meters deep *water well* (Figure 2.6), built in 1623, indicates that *The Lower Fortress* already existed, even if the towers are more recent. Solving the problem of the food and water stocks inside the fortifications was a great step forward, making the isolation and the starvation-inducing sieges ineffective (tactics used in the previous Ottoman and Mongol invasions).

The Middle Fortress (Figure 2.B) was strategically designed as a second chance in case that *The Lower Fortress* would fall under a possible siege, making it possible for the defenders to retreat and prepare themselves for a new assault inside *The Middle Fortress*. This strategy is similar to the principles of the watertight compartments of a ship. It is clear that the protected natural position and the massive fortifications would increase considerably the resistance against any siege, but, without a direct source of water, the defenders and the population would remain vulnerable to military isolation. *The Middle Fortress Gate* (Figure 3.9) was built without a tower and the defence was made through the crenelated wall fitted with murder holes and loopholes. Nearby this gate was once *The Galt's Tower* (Figure 3.8), whose foundations were preserved, providing enough clues to conclude its functions. The name of the tower was taken from the nearby village Ungra (German: Galt) and, probably, it was administrated by them, proving that the fortress served a wider area than just the adjacent town. The identified building materials from the foundation do not come from the same source, therefore the tower underwent several

The Pentagonal Tower (Figure 2.14) is the most interesting defensive building of the fortress due to its original structure and functionality, including the sharp angle of the flanking tower which indicates north, therefore making its shadow a sufficiently accurate time indicator. It is not proved that the shadow was used to read the time, but it is possible, considering the fact that, before the 18th century, the permanent residents of the fortress, would use the sun position to estimate the time (Maroși, 2015, p. 118). Another important aspect is that the tower was constructed to eliminate the blind spots of the two side walls and also to defend the vast ward of The Lower Fortress, through its dominant position.

The Scouts' Tower (Figure 2.10) or, according to Borcoman (2010, p. 20), The Gresbig Tower, was built in the 15th century and the name was given after a local personality. It is the largest and strongest flanking tower of the fortress, constructed to reduce the vulnerability of the topographically disadvantaged western walls. The wall between The Scouts' Tower and The Galt's Tower (Figure 2, between 10 and 8) keeps the defensive characteristics of the adjacent towers and, initially, the two were linked by a wooden gallery above which a covered wall-walk ensured maximum visibility. The entire defensive alignment was fitted with firearms openings, loopholes and probably machicolations (used to pour hot oil, water or stones out of). On the same alignment, there is *The Scouts' Secret Gate* (Figure 2.12), which was probably hidden by a false structure and defended by an overhanging brattice, accessible only with a ladder.

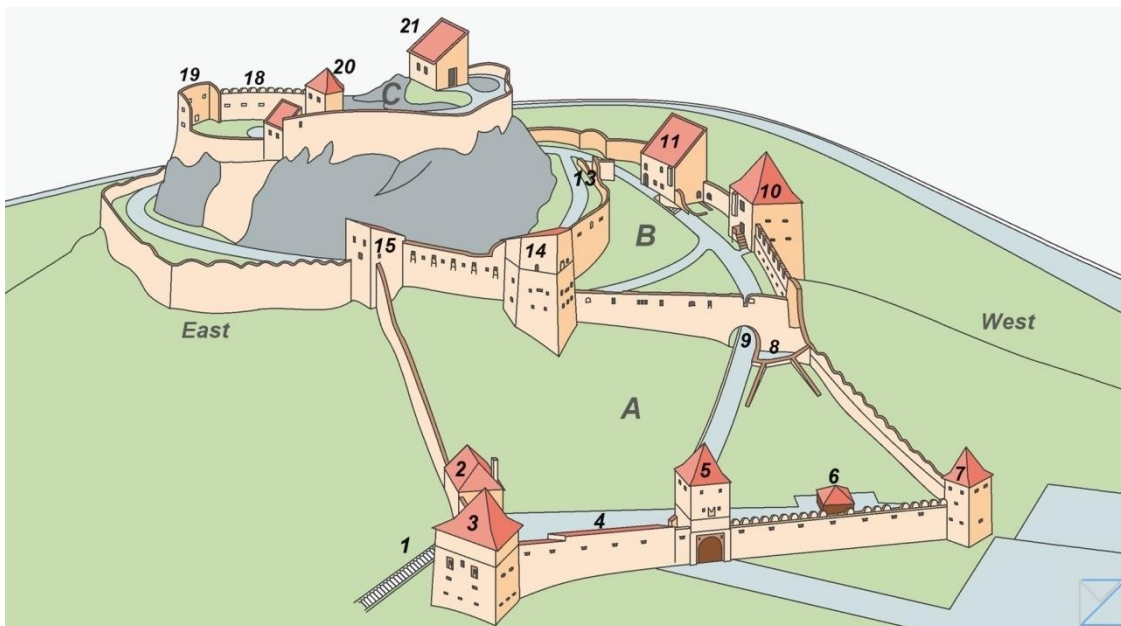
Figure 3: Bird's-eye view drawing of Rupea Fortress in its current form (north side)
 Drawing by MAROȘI Zoltan, 2016

additions, reconstructions, and changes. Along the same crenelated wall (Figure 3, between 8 and 14), in the past, there were several chambers that belonged to the local and regional officials, and also unpreserved wooden galleries and wall walks.

Between The Pentagonal Tower and The Scribes' Tower (Figure 3, between 14 and 15), the wall is fitted with combat niches and the preserved foundation of the second wall shows that, in the past, there were several private storerooms, whose defence was assured by the owners in case of a siege. It is possible that, above these private storerooms, there was a wall walk or there were even wooden galleries. *The Scribes' Tower* (Figure 3.15) is a simple rectangular flanking tower with a mono-pitched roof, with separate entrance to the basement and the upper floors. This tower was used as a deposit for the local and regional archives and also as a working place for local clerks and officials. The tower has several loopholes and other firearms openings. The curtain wall between The Scribes' Tower and The Chapel (Figure 2, between 15 and 11) defend the southern part of the fortress, taking advantage of the high slope of the hill. Along this wall, in the past, there were private houses defended by the owners, in case of a siege. Today, only the windows and the loopholes of those houses can be observed on the curtain wall.

The Chapel (Figure 3.11) is a massive building with a mono-pitched roof, a strengthened exterior wall and firearms openings, built in 1650. The religious function is attributed due to the original inscriptions "God is our strength and confidence" (Borcoman, 2010, p. 20). This building belonged to the parish house. Besides this building, up on the hill, there are the ruins of *The Thickened Tower* (Figure 2.13), which is linked to The Pentagonal Tower with a defensive wall fitted with firearms openings. This topographically advantaged wall inside The Middle Fortress could be seen as a Zwinger wall with two Zwingers (the area between two defensive walls, used as a trap in case that the curtain wall would fall under siege).

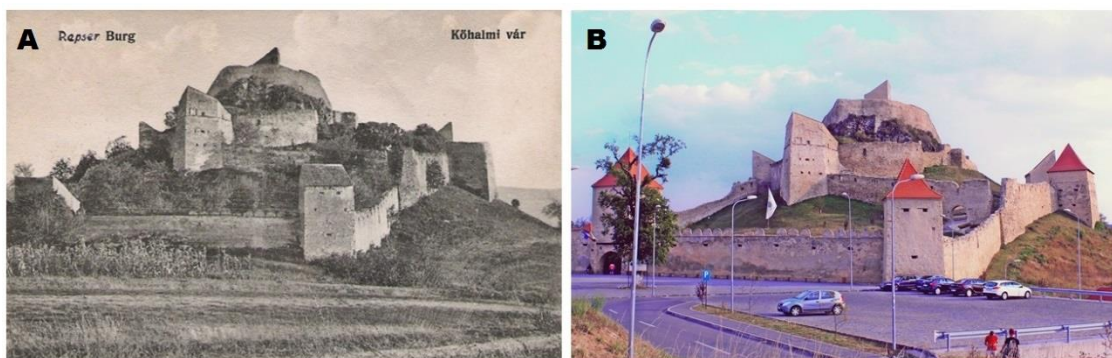
Figure 4: View over the north side of Rupea Fortress, A – before and B – after rehabilitation

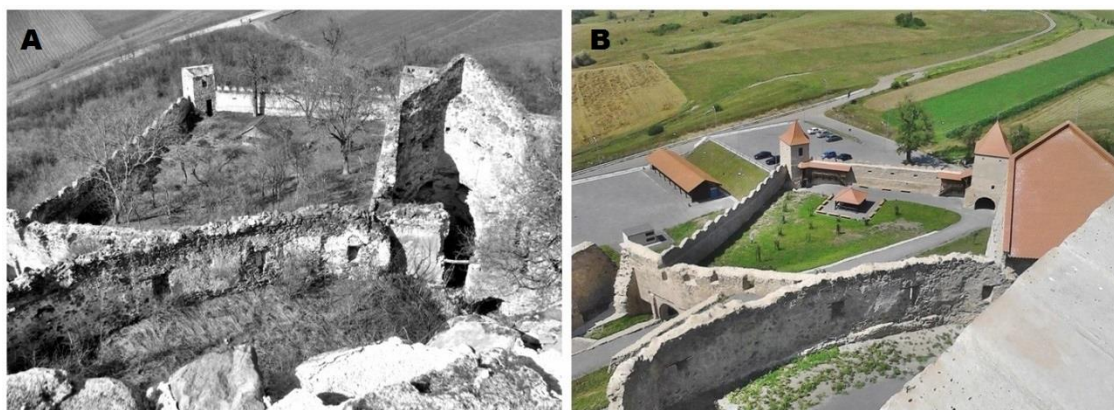
Figure 5: View over The Lower Fortress, A – before and B – after rehabilitation

We agree that if the investment would not have been made, the lack of conservation would have led to the irreversible degradation of the fortress (Figure 5.A) and the town would have missed the chance to harness the economic potential of tourism, but, at the same time, we

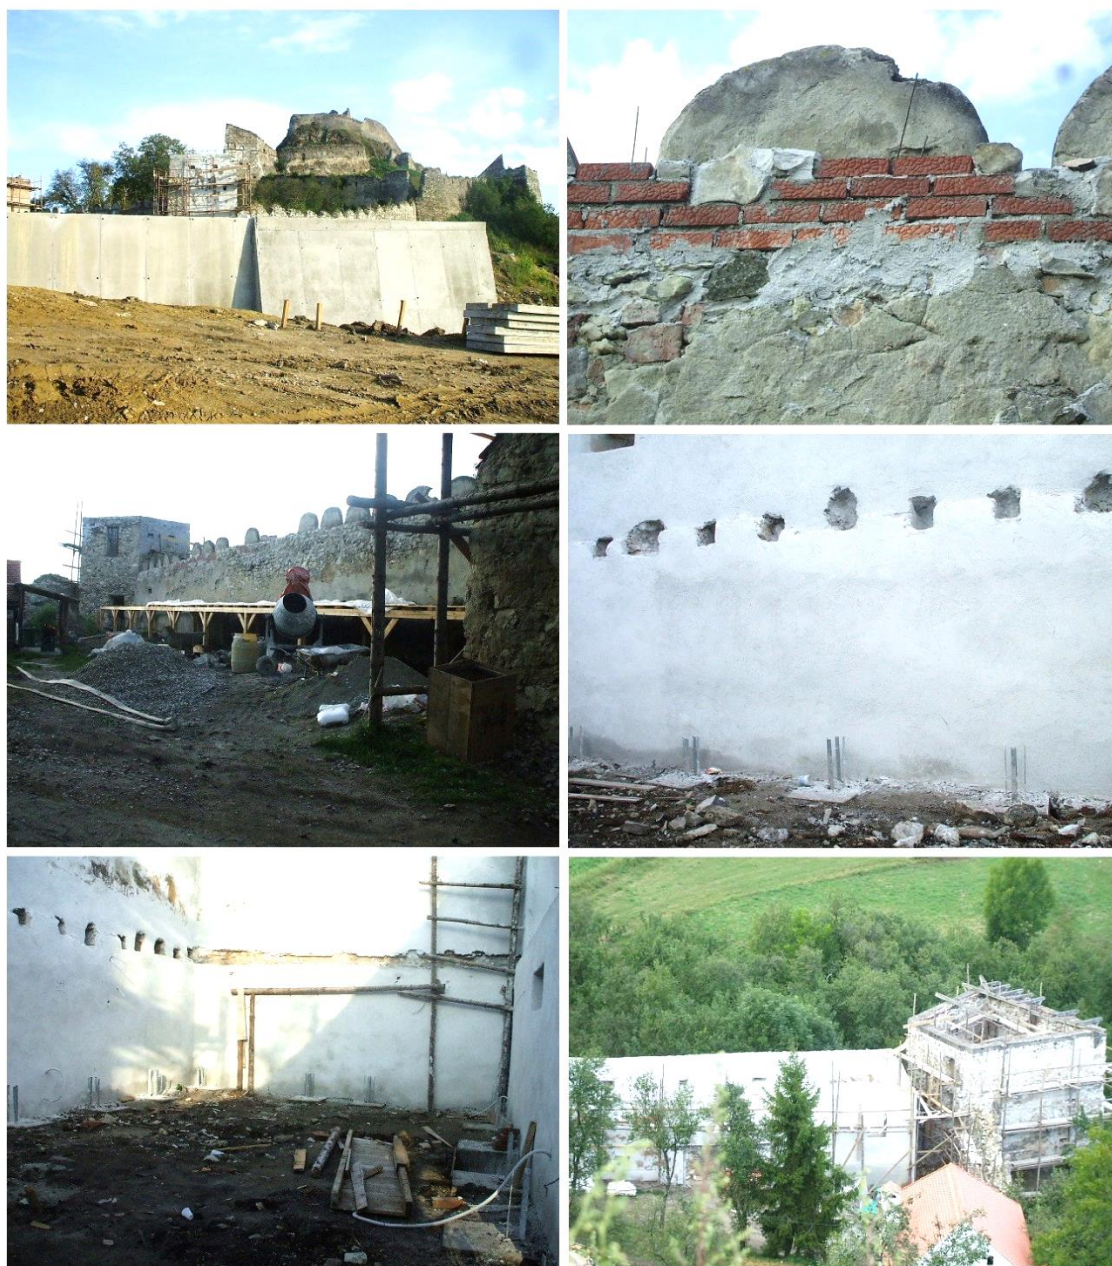
Figure 6: Details captured during rehabilitation (September 2010), underlining the invasive methods based on the extensive use of concrete in historical walls and foundations

Excessive use of concrete during the rehabilitation raised suspicions among specialists outside the project. Many people have visited the fortress and even if the majority left the place with a good impression, those few specialists (archaeologists, historians, urban planners, architects, geographers, environmentalists, etc.) were not as pleased. There are some general causes for their dissatisfaction regarding the project and all ends with the highly invasive methods used in the rehabilitation process: massive (monster) concrete blocks in the parking lot just a few meters from the historic wall, concrete injections in walls and foundations, inappropriate building materials and procedures (Figure 6). Yet, many did not see anything wrong in that.

The lack of thorough studies led the rehabilitation to a long list of unsolved or partially solved problems, which were temporarily forgotten due to the large number of visitors which exceeded by far the estimations. For every year, since 2013, the average number of visitors has been 60,000, with an accelerated annual growth at the beginning and moderate in 2016, with the remark that numerous newspaper articles exaggerate the real numbers. In this way, the public opinion was influenced and important issues such as the unexpected discovery of the only preserved gothic wooden framing in the The Scribes’ Tower (Figure 2.15), among other 17th century foundations of houses, has been neglected. The lack of a guide or other informative panels let the visitors to pass along such significant items without drawing their attention and this way the general opinion about Rupea Fortress is focused on its emptiness; without the typical romantic environment of the ruins, the visitors perceive the space without the attributes of historical or cultural heritage (Figure 6).

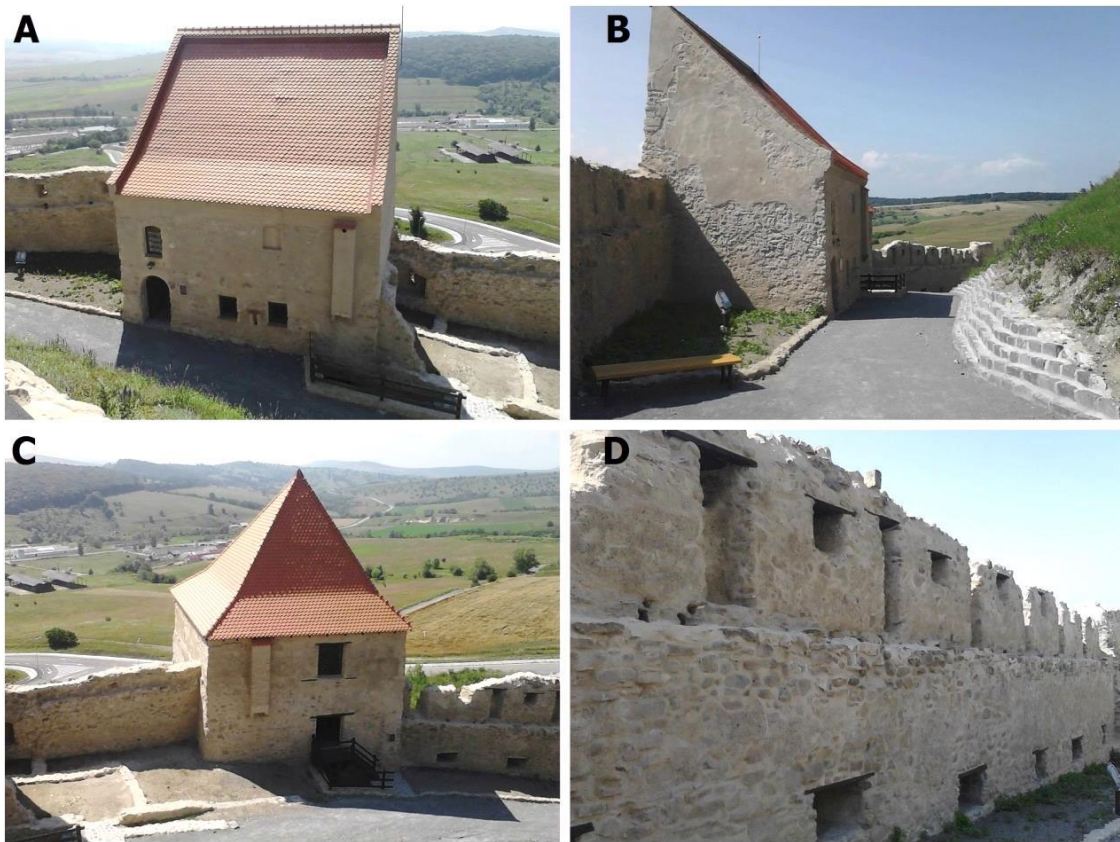
Figure 6: View over A, B – The Chapel, C – The Gresbig Tower or Scouts’ Tower and D – details on the wall between The Gresbig Tower and The Middle Fortress Gate after rehabilitation
